SERVICE BULLETIN

Dec. 28, 2015

28 Repair/Replacement For Cracked Weld On Old Style Side Output Muffler

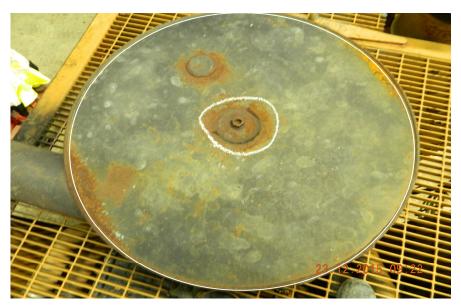
We are addressing the issue with the old style side output muffler cracking. Once the crack has started water will fill the engine and eventually cause a hydro lock in the cylinder.

We suggest checking these mufflers when they come into the yard. They can be cracked on the inside by the lifting nut, or on the outside where the large white circle is. If it is cracked it can be welded, if there is excessive damage replace it with a new style muffler.

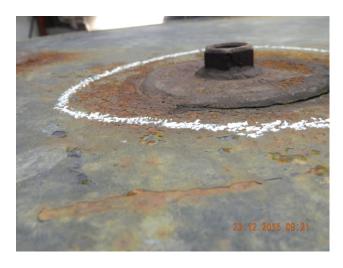
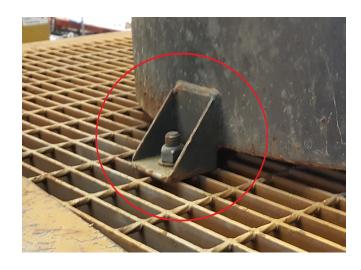
See the below image for reference of an old style side muffler. If the mount is like the one circled in red it is the old model that will crack.
